Nordicco's Northern Air Aggressive Environment HVLS fan tests:

Environmental test of indoor fan and fan assembly parts

Nordicco A/S

Report no.: 121-32625-1

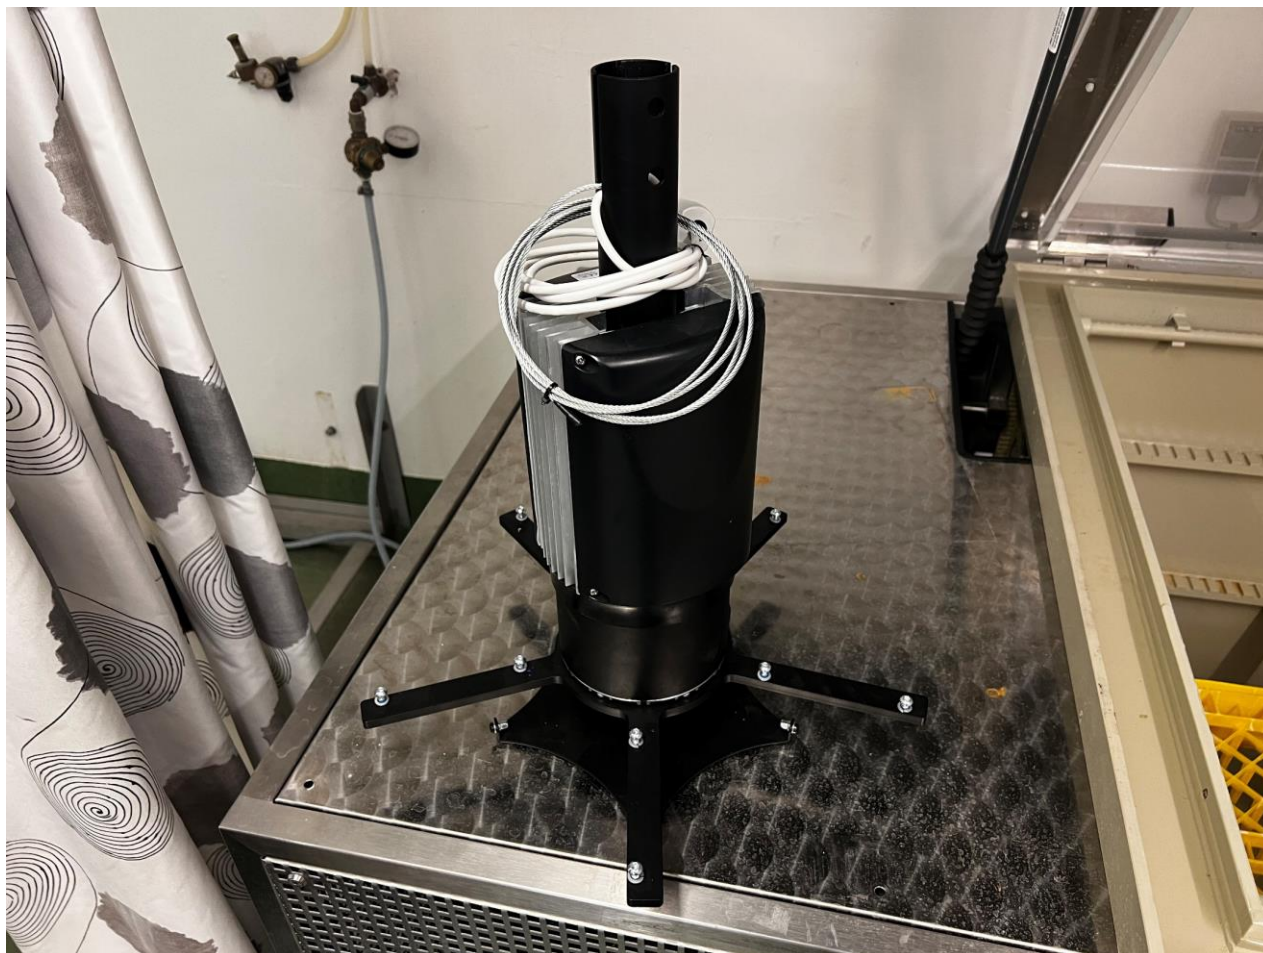
Photo 1 Test object.

Name of test object	Indoor fan
Model / type	Northern Air Aggressive Environment
Part no.	NordicX00NA-AE
Serial no.	100314
Manufacturer	Nordicco A/S
Supply voltage	220 – 240 V _{AC}
Comments	Test object for salt mist test

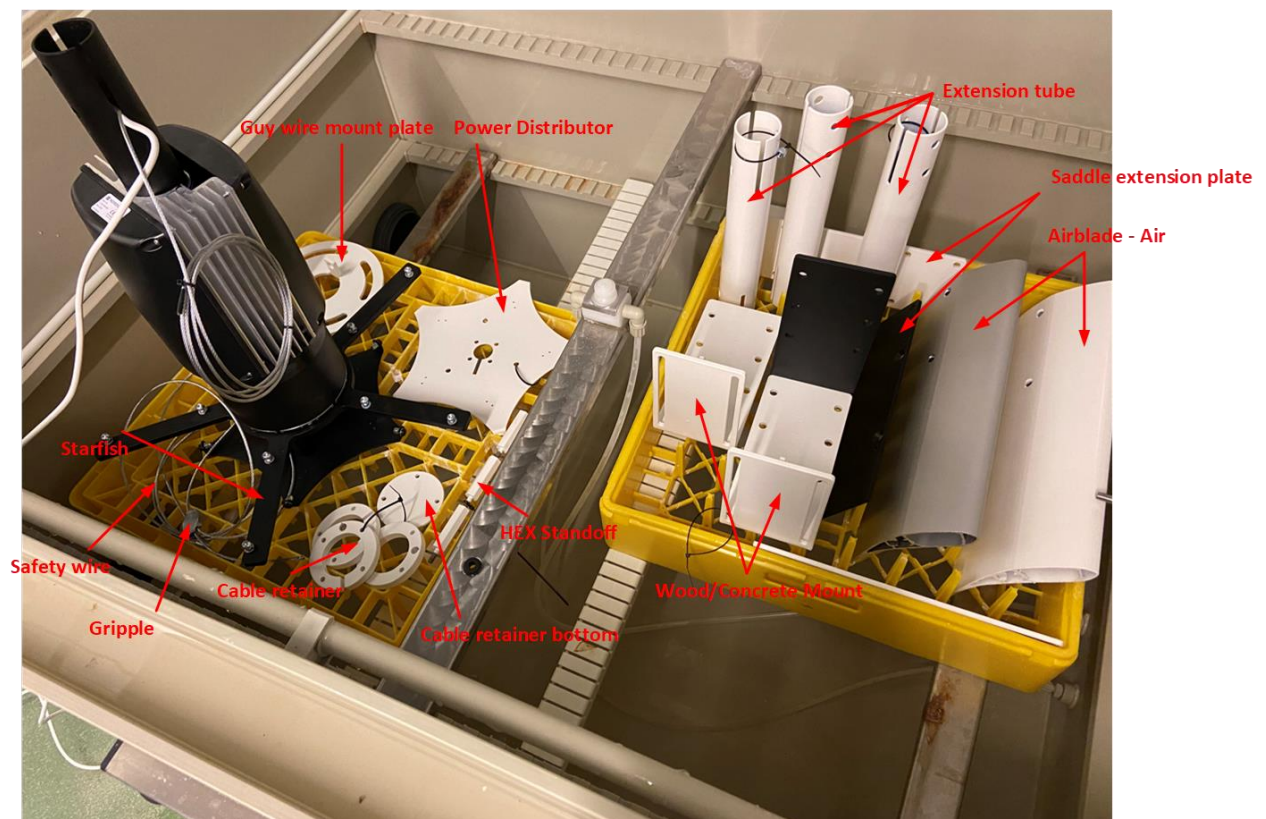
Photo 2 Test objects. Assorted pieces for fan assembly for salt mist test.

Comments Three types of coating are tested. C2, C3 and C4 powder coating and an air blade with/without coating.

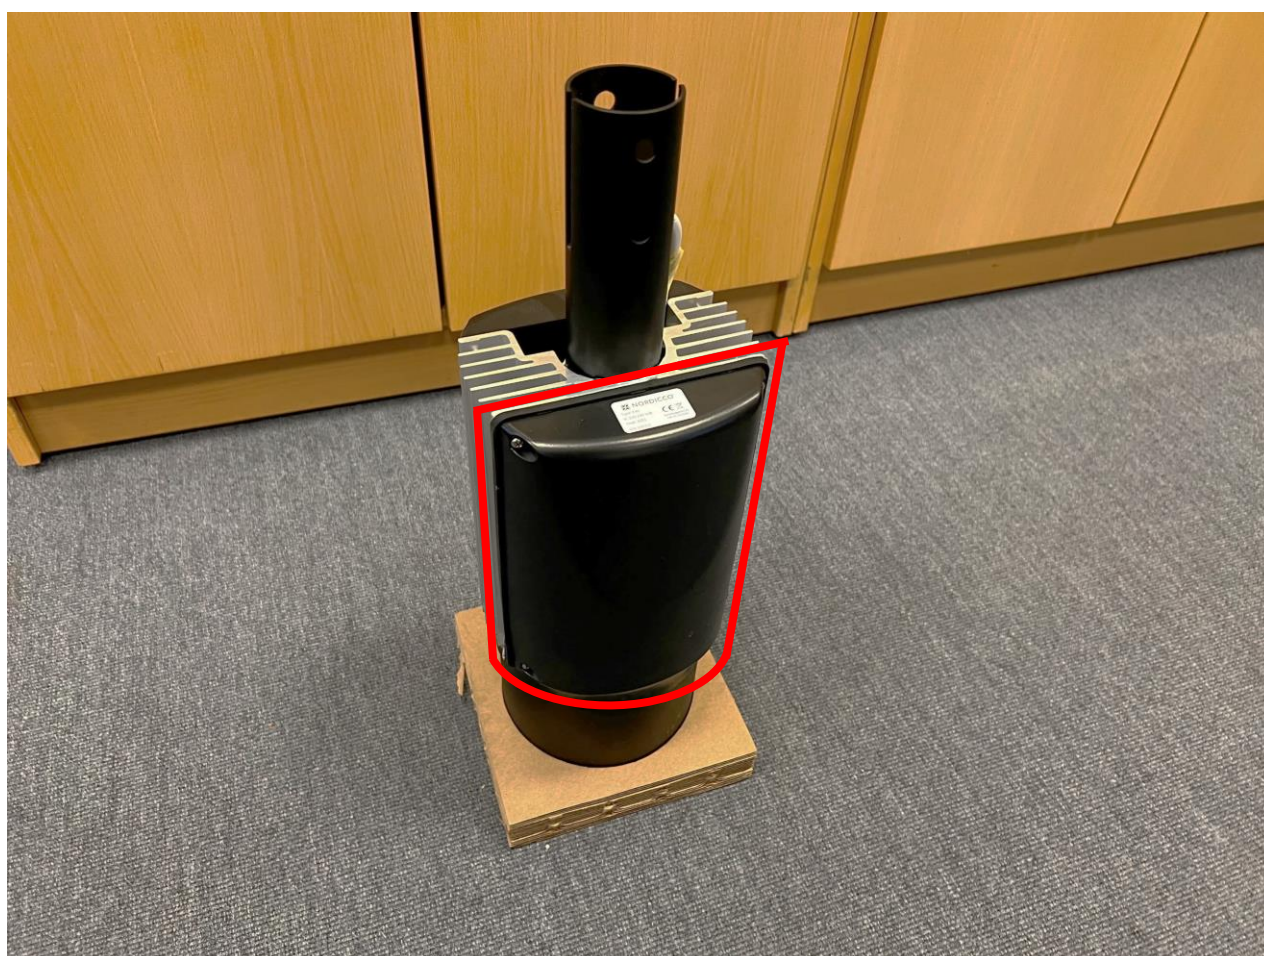
Photo 3 Test object. Enclosure boundaries marked by red square.

Name of test object	Indoor fan
Model / type	Northern Air Aggressive Environment
Part no.	NordicX00NA-AE
Serial no.	100311
Manufacturer	Nordicco A/S
Supply voltage	220 – 240 V _{AC}
Comments	Test object for IP5X

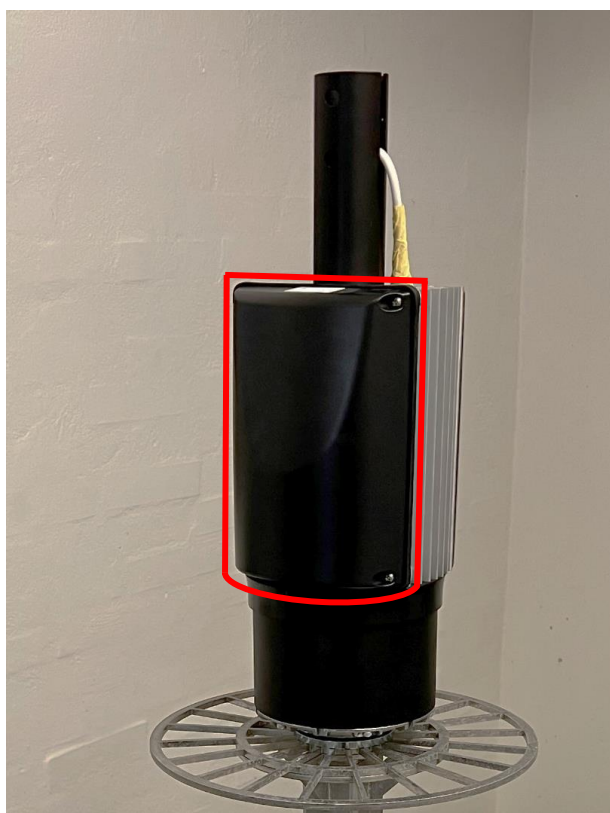
Photo 4 Test object. Enclosure boundaries marked by red square.

Name of test object	Indoor fan
Model / type	Northern Air Aggressive Environment
Part no.	NordicX00NA-AE
Serial no.	100312
Manufacturer	Nordicco A/S
Supply voltage	220 – 240 V _{AC}
Comments	Test object for IPX5

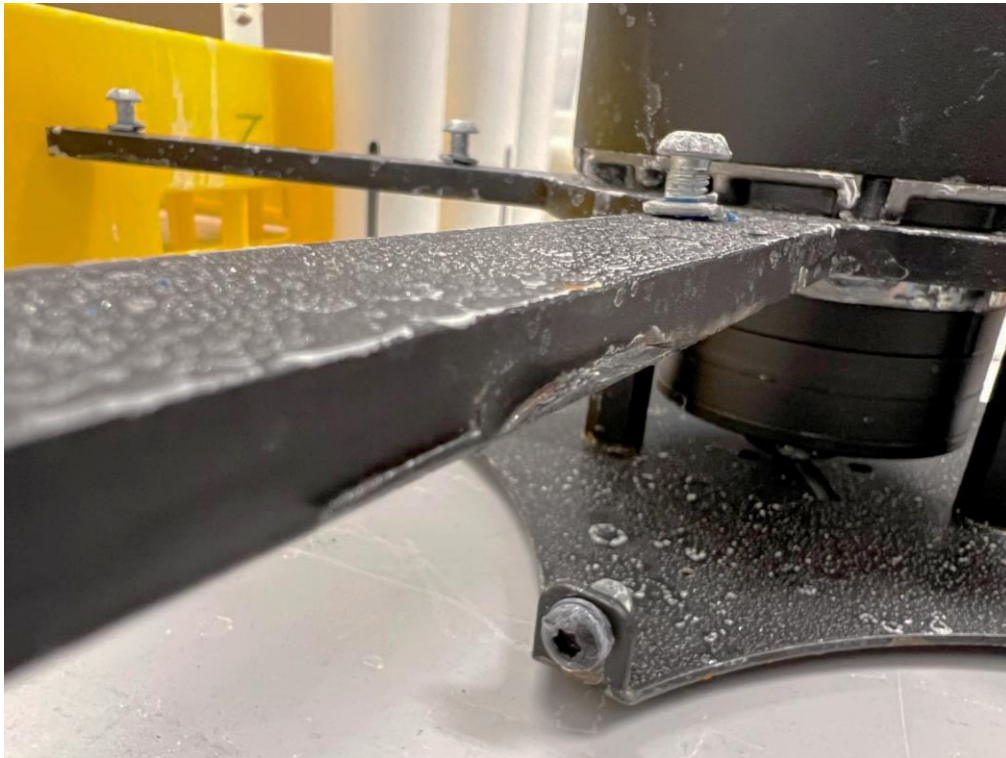
Photo 9 Visual inspection (fan). Corrosion and peeling of coating.

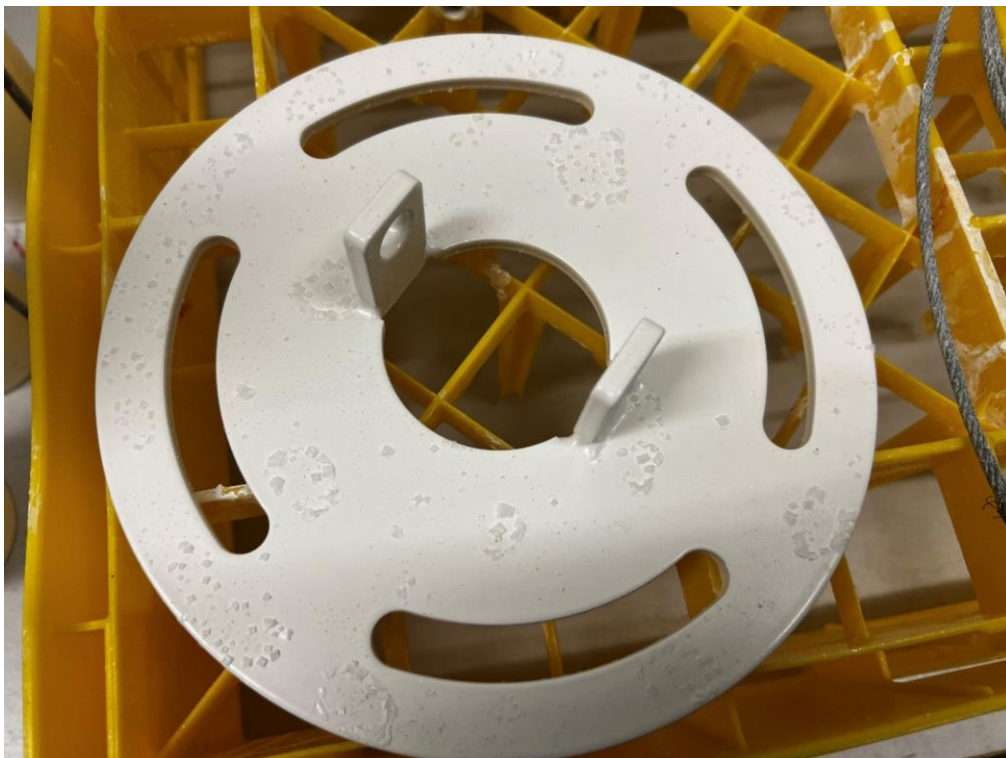
The conclusion is based on the results from example picture 12 (page 15) which is a C4 coated sample along with the brackets on picture 17 (page 18) which is also C4 coated (including applied damages and repairs). The test notes a light coloration difference between the repair coating and the original coating, but no signs of corrosion.

Photo 12 Visual inspection. (Guy wire mount plate, P/N: 20024) no signs of corrosion.

On the basis of the conducted tests the Northern Air Aggressive Environment in coating C4 is suitable for applications in corrosive environments.

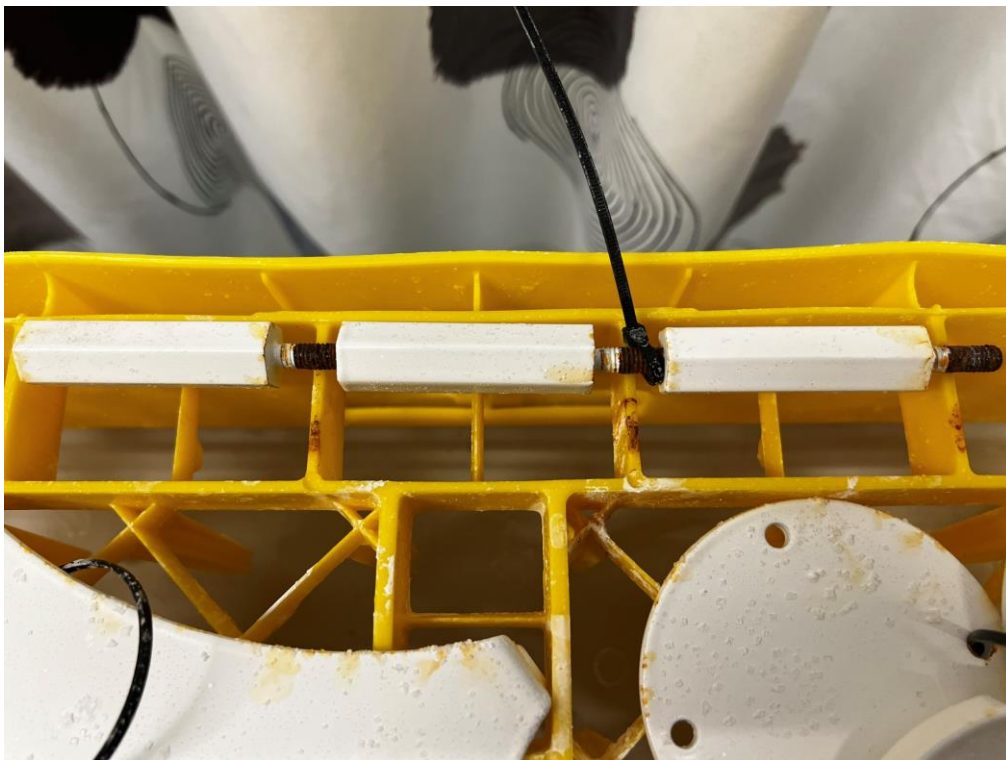
Photo 16 Visual inspection. (Hex standoff P/N: 20006) corrosion along edges and on screw thread.

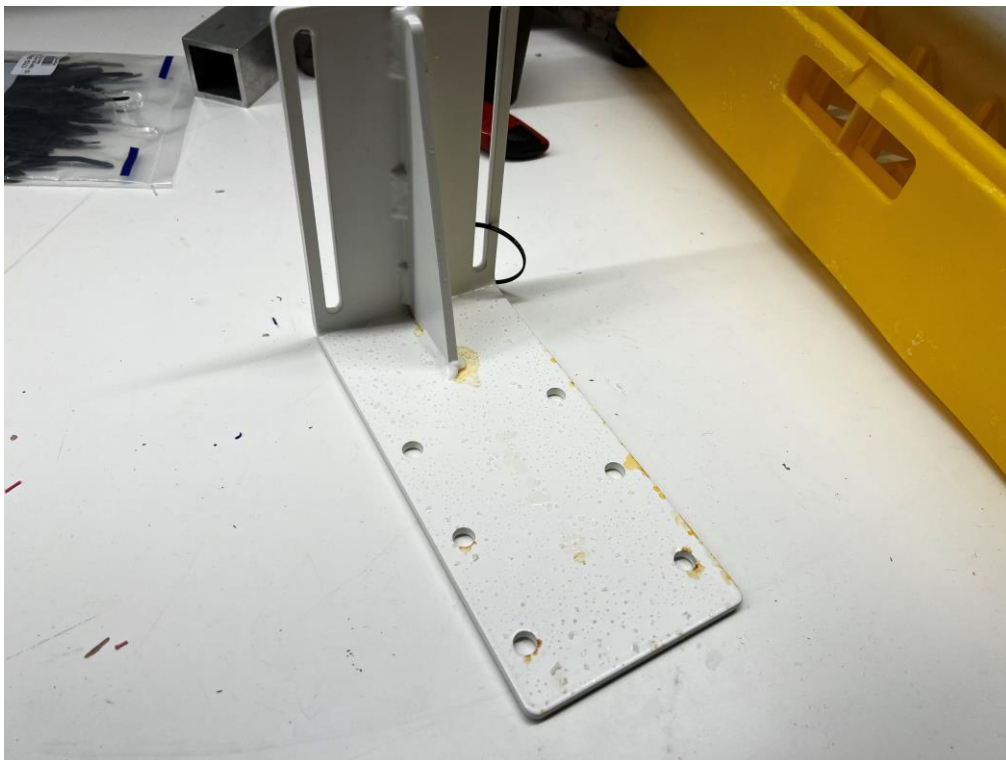
Photo 18 Visual inspection. (Wood/concrete mount P/N: 20032) slight coloration on repaired cracks, and corrosion on edges and crevice from missing welding.

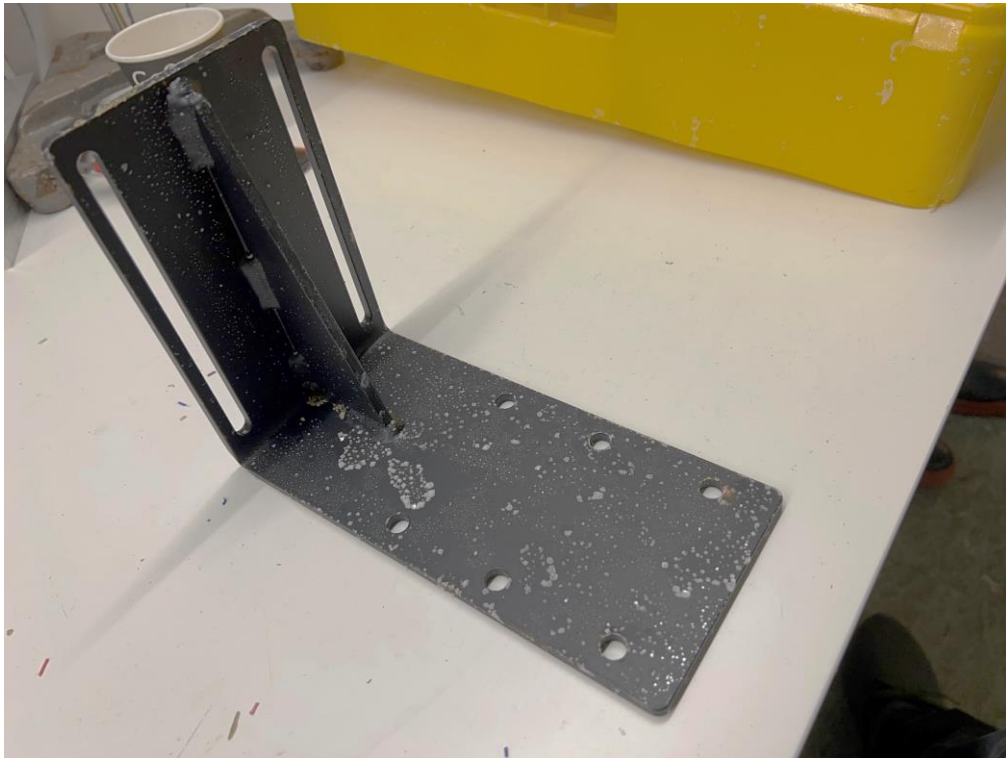
Photo 19 Visual inspection. (Wood/concrete mount P/N: 20032) corrosion on scratches made by the client and along edges and crevices from missing welding.

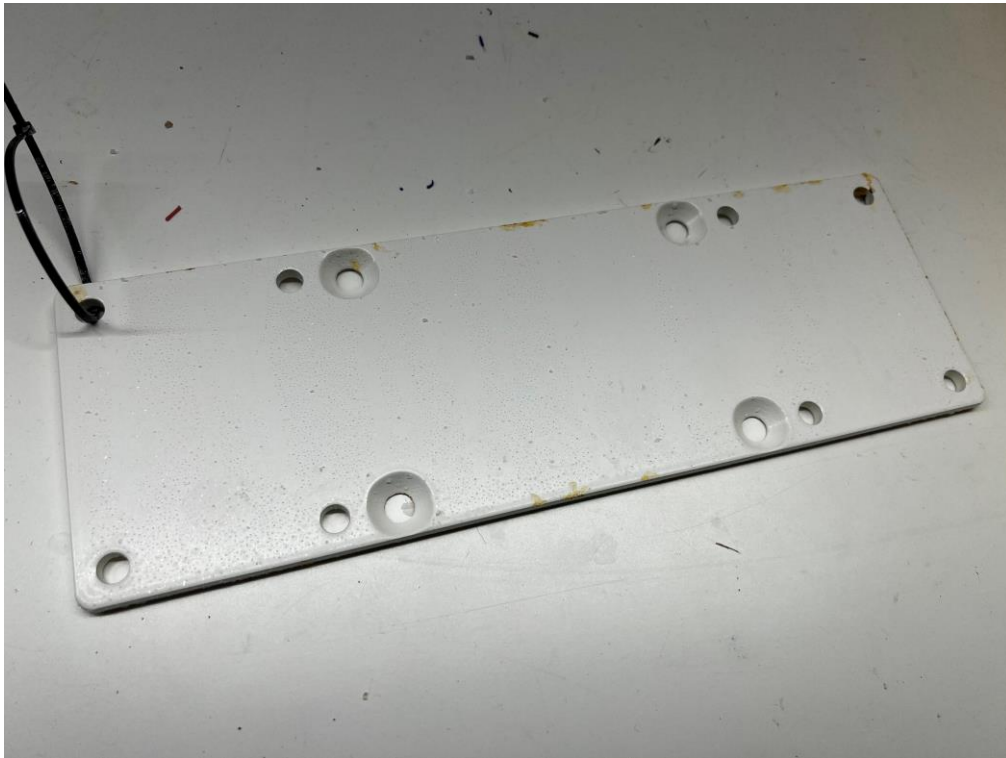
Photo 21 Visual inspection. (Saddle extension plate P/N: 20028) corrosion on scratches made by the client and along edges.

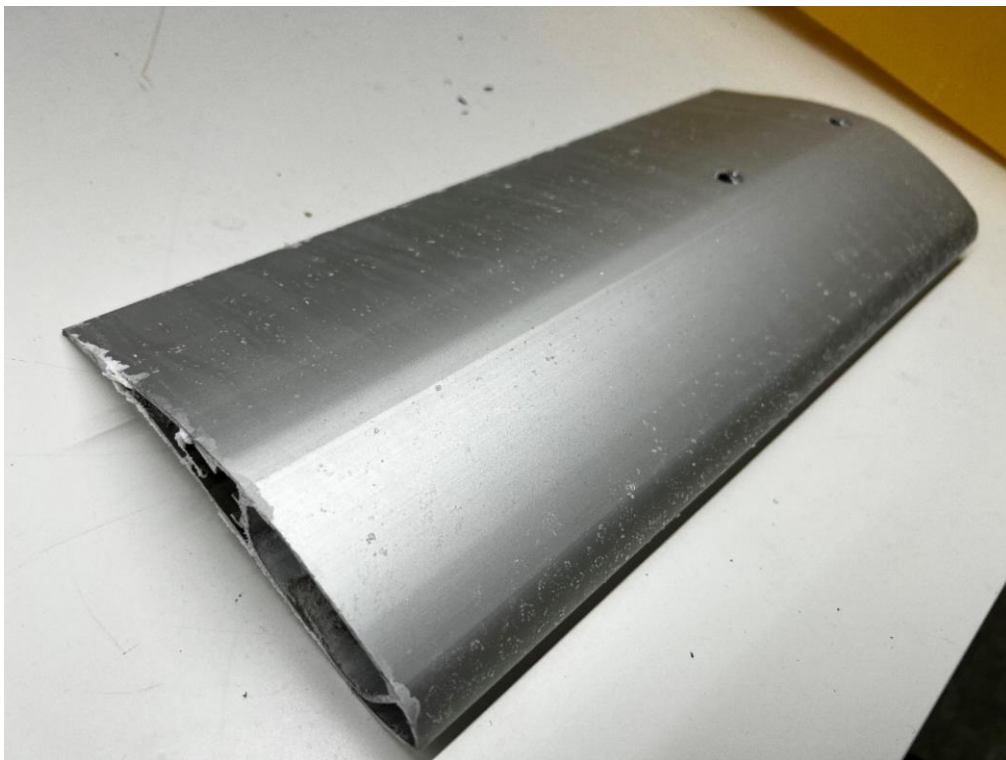
Photo 22 Visual inspection. (Air blade P/N: 20201) no changes observed.

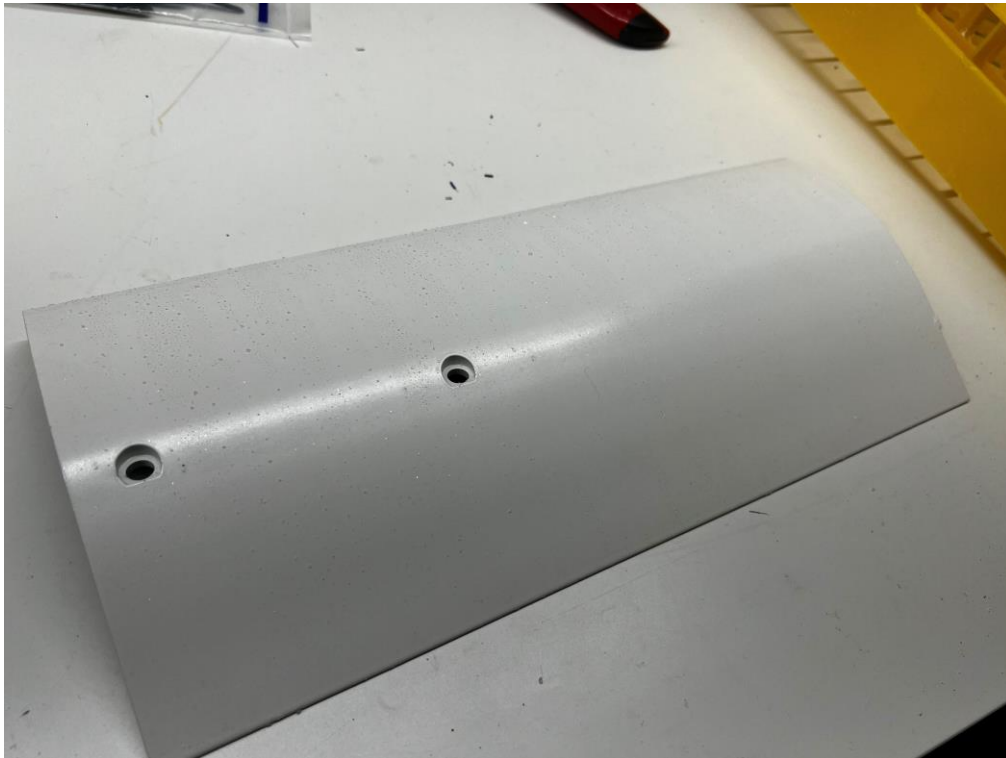
Photo 23 Visual inspection. (Air blade P/N: 20201) no changes observed.

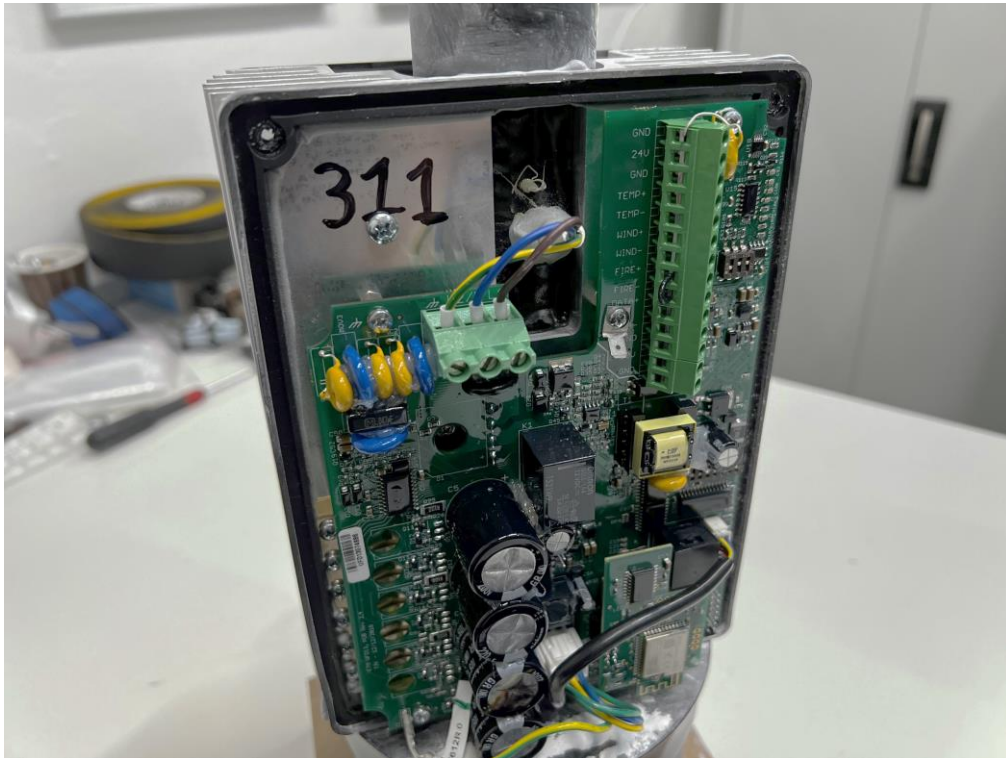
Photo 28 Visual inspection. No ingress of dust observed inside the enclosure of the test object.

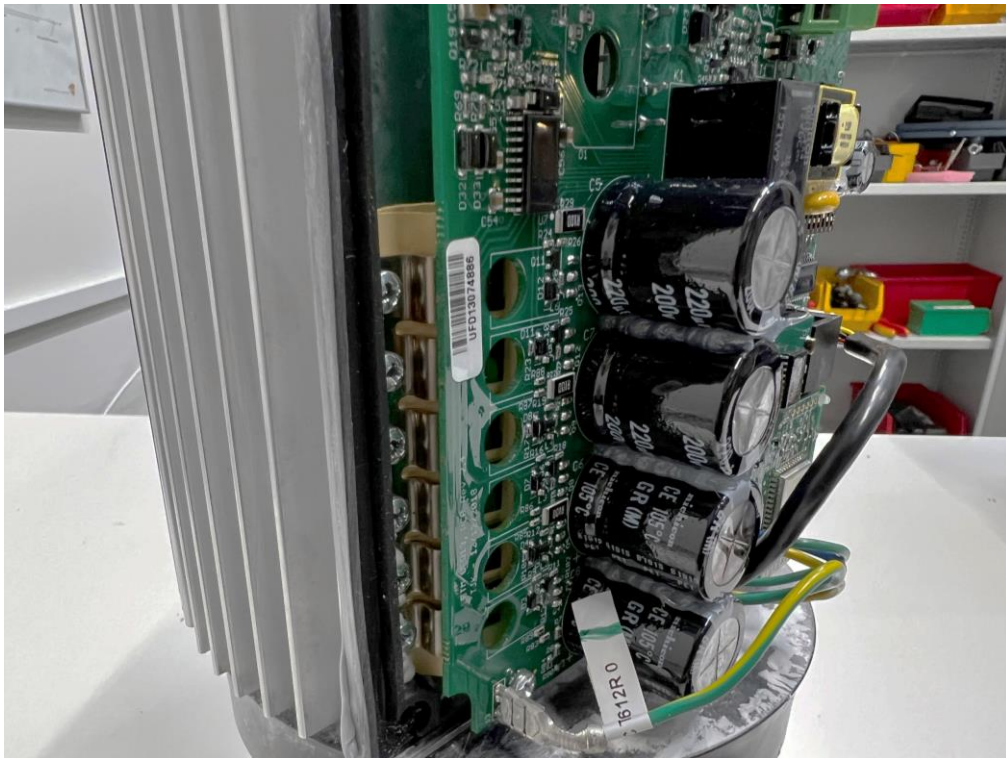
Photo 29 Visual inspection. No ingress of dust observed inside the enclosure of the test object.

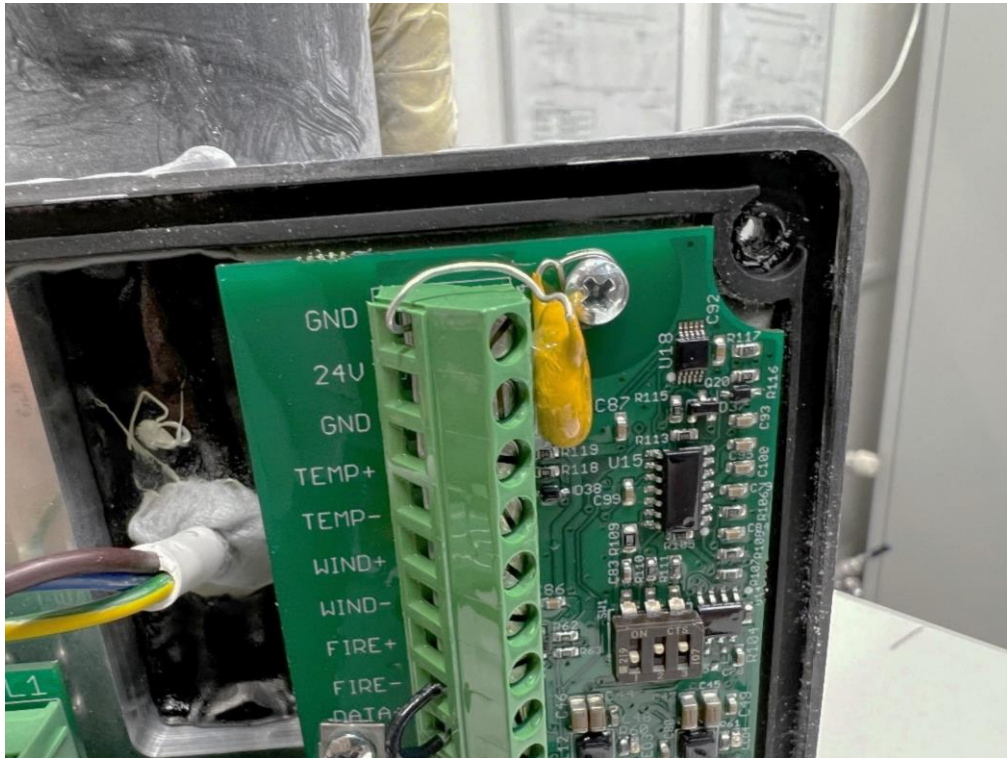
Photo 30 Visual inspection. No ingress of dust observed inside the enclosure of the test object.

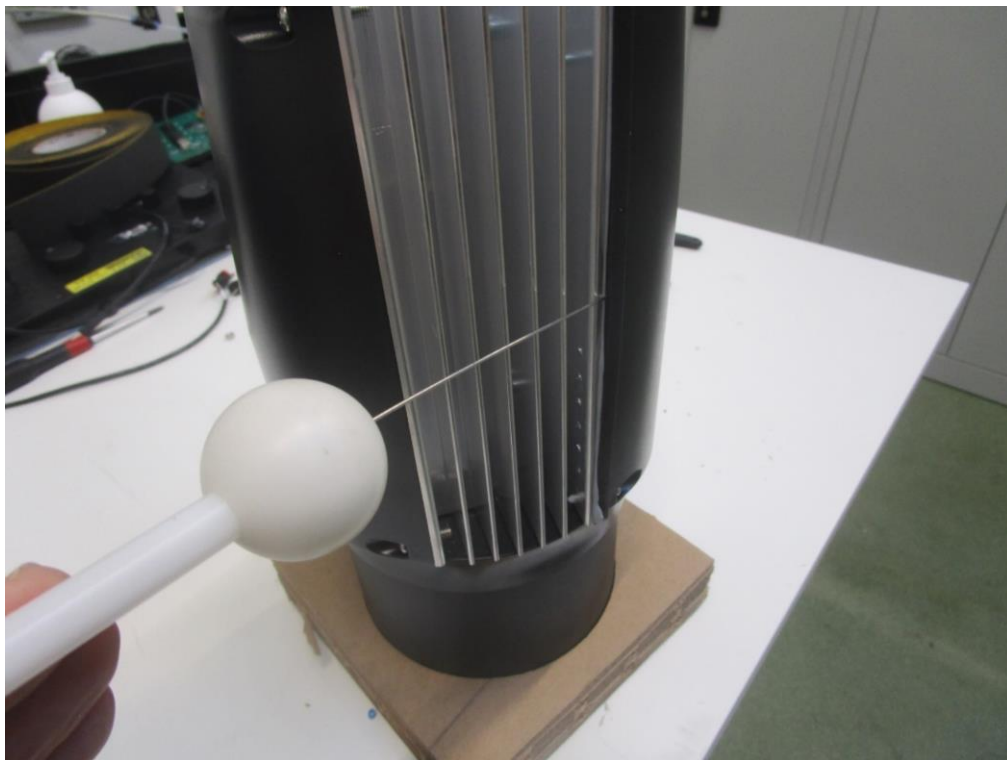
The test was performed as specified. A visual inspection showed that there was no accumulated dust inside the enclosure. Furthermore, an \varnothing 1.0 mm test wire could not enter through any holes or openings, and adequate clearance was kept between the test wire and hazardous parts.

Photo 31 Enclosure protection, IP5X. 1 mm probe could not enter the enclosure and adequate clearance was kept.

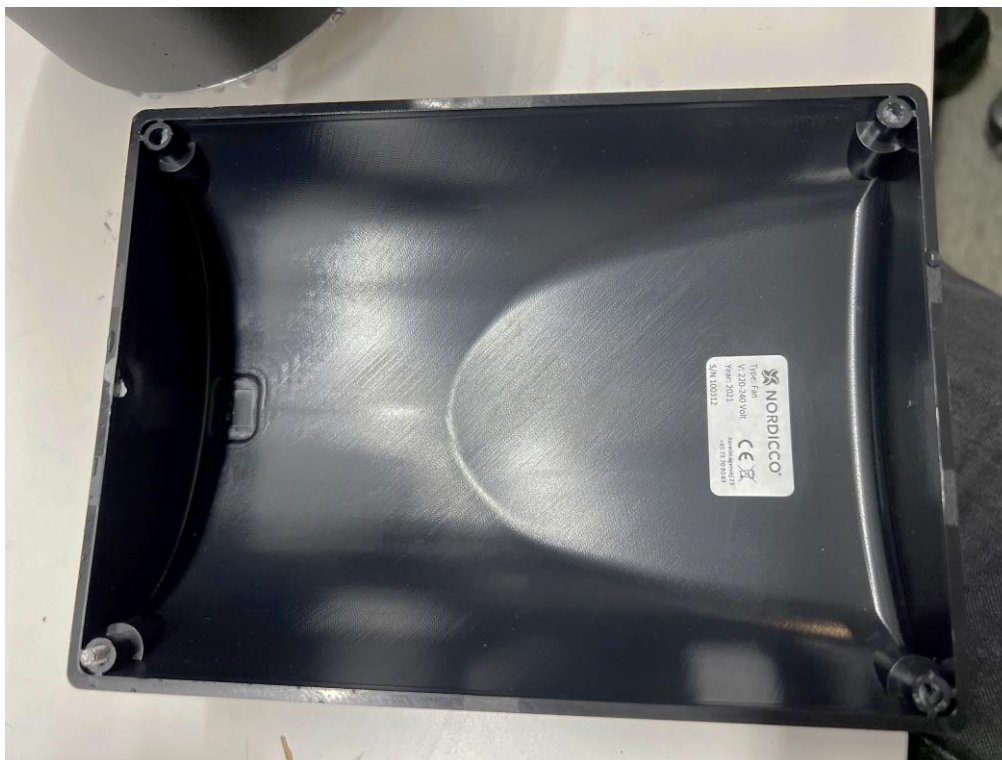
The test was performed as specified. The visual inspection showed no ingress of water inside the test object.

Photo 34 Visual inspection, IPX5. No ingress of water observed inside lid.

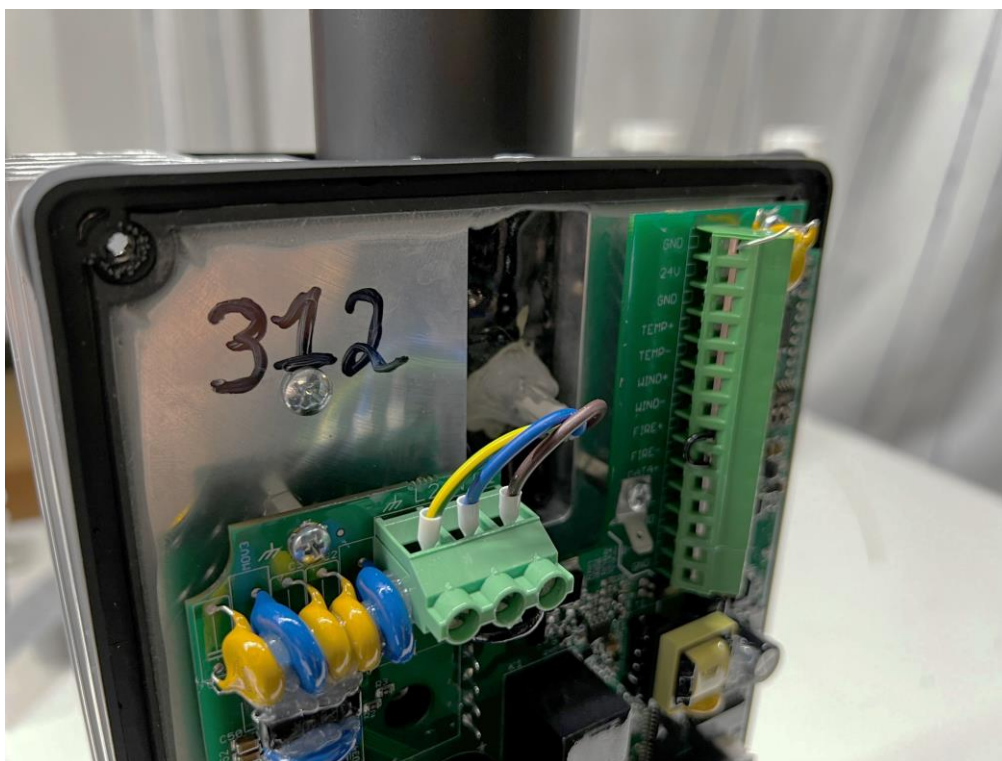
Photo 35 Visual inspection. IPX5. No ingress of water observed inside the enclosure of the test object.
